## Cracks in Oven Roof.

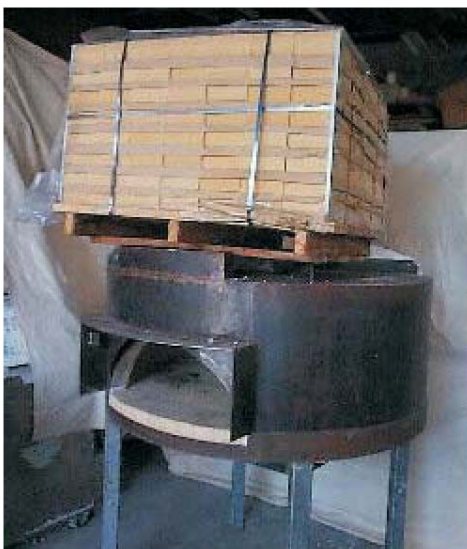
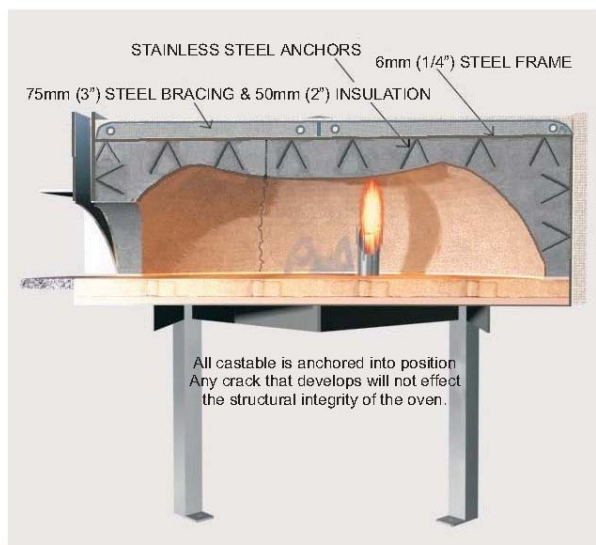
All materials used in the construction of these ovens are classified as “food-safe”. As seen in the pictures below the Beech Oven is strong, solid and dependable.
